DEPARTMENT OF TRANSPORTATION**DIVISION OF ENGINEERING SERVICES**

Contract #: 04-0120F4Cty: SF/ALA Rte: 80 PM: 13.2/13.9File #: 69.28**WELDING INSPECTION REPORT****Resident Engineer:** Pursell, Gary**Address:** 333 Burma Road**City:** Oakland, CA 94607**Report No:** WIR-000876**Date Inspected:** 24-Oct-2007**Project Name:** SAS Superstructure**OSM Arrival Time:** 630**Prime Contractor:** American Bridge/Fluor Enterprises, a JV**OSM Departure Time:** 1500**Contractor:** Zhenhua Port Machinery Company, Ltd (ZPMC), Changxing Island **Location:** Shanghai, China**CWI Name:** Shi Zhi & Li Gang**CWI Present:** Yes No**Inspected CWI report:** Yes No N/A**Rod Oven in Use:** Yes No N/A**Electrode to specification:** Yes No N/A**Weld Procedures Followed:** Yes No N/A**Qualified Welders:** Yes No N/A**Verified Joint Fit-up:** Yes No N/A**Approved Drawings:** Yes No N/A**Approved WPS:** Yes No N/A**Delayed / Cancelled:** Yes No N/A**Bridge No:** 34-0006**Component:** Caltrans Mockup**Summary of Items Observed:**

Caltrans Quality Assurance (QA) Inspector, Mike Hasler was present to observe the fit up, welding and related activities associated with the fabricating of Caltrans Mock-up, 77M, 89M,

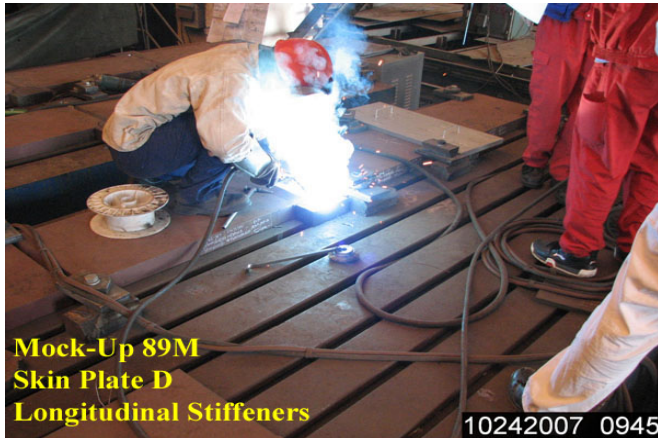
Item Description	WBS	Dwg No.	Status
1 Stiffener Plates	NA	NA	Machining Bevels
Mock-Up 89M, Stiffener Plates: Caltrans QA Inspector observed shop workers machining. Caltrans observed plate perimeter, weld bevels (45 degree) being machined, piecemark Gt-301-8A, GT-301-7B and GT-301-8A plate side (90 degree) to plate surface. The machined surface appeared to be smooth and uniform and, in conformance with the contract specifications.			
2 Skin Plate D	NA	NA	Work in Progress
Mock-Up 89M, Skin Plate D, Longitudinal Stiffener Plates: Caltrans QA Inspector observed flux cored arc welding (FCAW), splice plate root pass weld, joining piecemark mp534C-1 to mp534B-1 stiffener plates, in the flat position. The welder is identified as Mr. Lei Leihao, welder stamp 053619. The welder is using welding procedure specification WPS-B-T-2231-B-U3-F. Caltrans QA observed ZPMC Quality Control inspector, Mr. Zhan Chen Sun and ZPMC Certified Welding Inspector (CWI), Mr. Xu Le feng, monitoring welding activities at the workstation. Caltrans QA Inspector measured current welding parameters at approximately 335 amps, 31 volts and 335 millimeters per minute (mm/min) travel speed. Preheat and interpass temperatures were verified during welding activities. The preheat temperature prior to the start of welding measures more than 110 Celsius (230 degree Fahrenheit) but less than 232 Celsius (450 degrees Fahrenheit) during maximum interpass temperature verification. FCAW welding consumable is verified and identified as Supercored 71H, classification E71T-1, diameter 1.4 mm (.055 inches). Following digital

picture illustrates welding in progress.

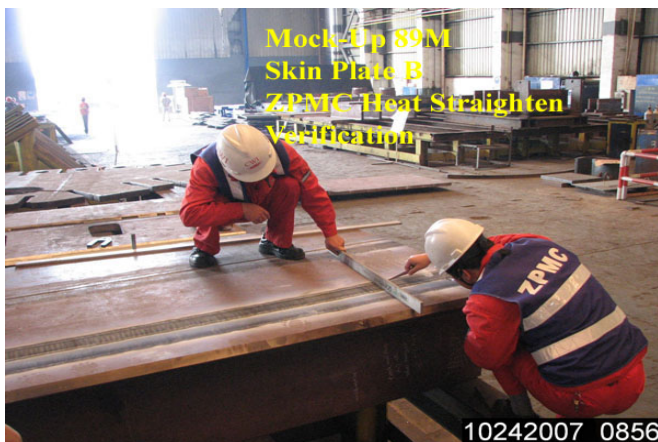
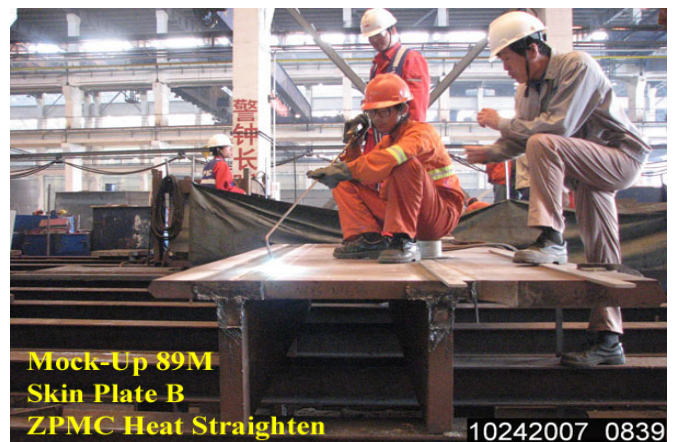
Mock-Up 89M, Skin Plate B: Caltrans QA Inspector witnessed the heat straightening of skin plate B assembly, per procedure HSR1 (CT)-124, Revision 0. ZPMC applied heat, with the use of a hand held oxygen/acetylene-fuel flame type torch. Caltrans Observed heat applied at three heat passes. ZPMC monitored the applied heat to the plate, with the use of a hand held device, identified as an infrared laser temperature gun. Caltrans QA Inspector randomly observed that the maximum heat being applied to the plate is approximately 580 Celsius. The procedure states, maximum heat to be applied, 650 Celsius. The heat straightening of the plate appeared to be in general conformance with the procedure and contract documents. Caltrans QA Inspector observed ZPMC QC inspector, Mr. Fu Yun Hong and Certified Welding Inspector (CWI), Mr. Xu Le Feng monitoring the heat straightening of the skin plate B assembly. Following digital pictures illustrate method and verification of the heat straightening of the plate.
